Report No. FAA-RD-78-28

TESTS OF CRASH-RESISTANT FUEL SYSTEM FOR GENERAL AVIATION AIRCRAFT

MARCH 1978

INTERIM REPORT

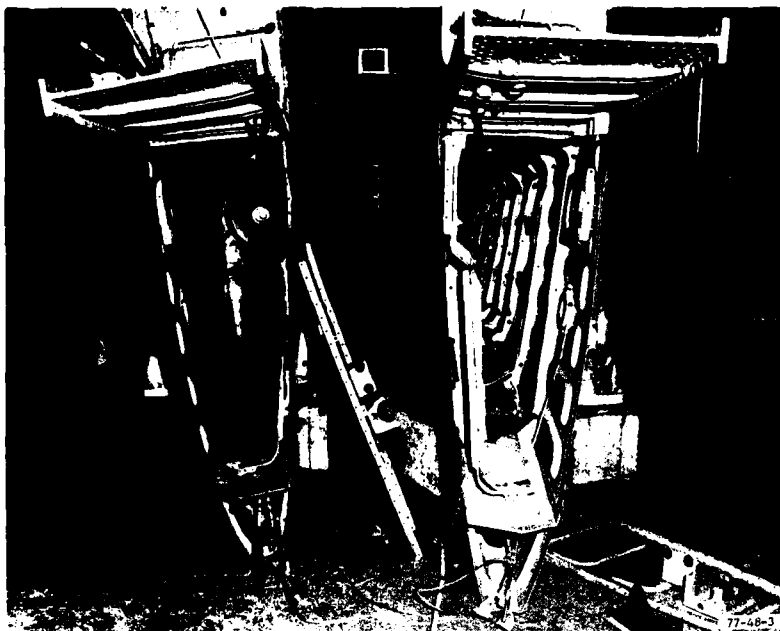
FIGURE 3. INSTALLATION OF TWO-PLY FUEL TANK

- ① EQUIV. TO MS33656-8
- ② EQUIV. TO MS33514-12 MOD.
- ③ EQUIV. TO MS33649-12

The crashworthy tanks were installed by removing the bulkhead rib at the wing root after the wing was removed from the aircraft. The tank was slid into the wing, after which the rib was riveted back in place, and the wing was reinstalled. Referring to figure 3, it is seen that the tanks occupy the wing leading edge, the most hazardous location. No modifications were done on the wing where the filler flange fitting, access, and gauge fittings were located. The frangible couplings (figure 4) were installed at the fuel outlet and vent fittings. As bulkhead ribs interfered with these fittings, 2-inch-diameter clearance holes were cut in the ribs. To provide a more severe operating condition for the couplings, aluminum tubing was used in lieu of the flexible tubing normally used for fuel lines. Actuating arms were installed to impact these lines when the arms contacted the ground during the crash (figure 5).
